**Flood Control Project Maintenance  
Levee Inspections**

**Fall 2018 Levee Maintenance Deficiency Summary Report**

**Sacramento River Basin**

## Marysville Levee Commission

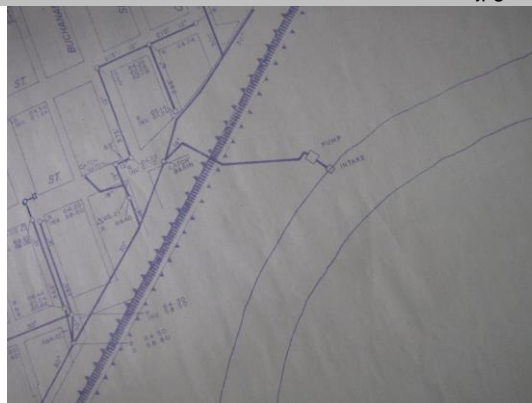
Photo 1 of 1 : UCIP\_FA\_2018\_52822\_17200.jpg

Comment Code					
Inspector Comment					
FS_ID:52822					
DS_ID:19142					
EP_NO: 7066					
Repair Type: Non-Urgent					
Crossing Status: Indicator Found					
UCIP Comments: 03/14/2013 Unable to take coordinates due to limited access to waterward side, used desk study coordinates. (DWR UCIP - O. Magana)					
FIELD_STRUCT_DESC: 14-inch drainage pipe through levee, 6 feet below levee crown. Discharges into Ellis Lake. Slant pump mounted on metal pump stand located approximately 150 feet from waterside toe. (14-inch pipe authorized under Permit No. 7066B, 7066A, 7066, 1970-City of Marysville). [Additional Reference(s): DWR Levee Logs, 1993 and 2005]					
FS Date: 3/14/2013

As-built dwg provided by Marysville Water Waste Treatment Plant.

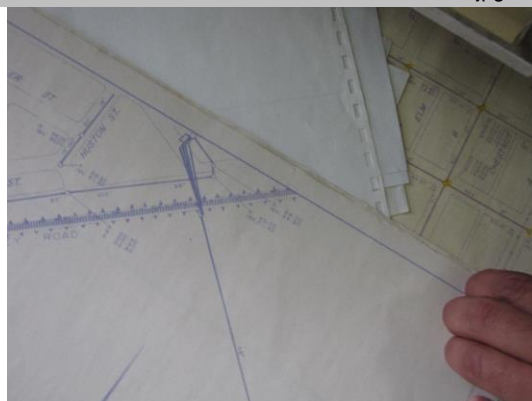
Photo 1 of 3 : UCIP\_FA\_2018\_52824\_69830.jpg

Comment Code						
Inspector Comment						
FS_ID:52824 DS_ID:19145 EP_NO: 2149 Repair Type: Non-Urgent Crossing Status: Indicator Found UCIP Comments: 03/14/2013 Depression observed on waterward toe filled with concrete rubble and riprap. Need to coordinate with City to determine records and extent of modifications if any. (DWR UCIP - O. Magana) FIELD_STRUCT_DESC: [17th & Howell Pump Station] 1 of 4: 24-inch steel drainage pipe (instead of 30 inch as specified in permit), buried 15-feet below the crown. Runs parallel to other drainpipes, encased in concrete approximately 1-foot spacing. Pipe extends from storm water pump house to manhole (259 feet) north of landside (LS) toe. Flap gates and vent pipes at waterside (WS) toe. Discharges into concrete distribution box (3-foot by 4 foot). (three 30-inch and one 10-inch pipes and a 48-inch outfall pipe across the berm along the right bank of the Yuba River authorized under Permit No. 2149, 1956-City of Marysville). [Additional Reference(s): DWR Levee Logs, 1993 and 2005] FS Date: 3/14/2013

As-built provided by Marysville Water Treatment Facility.

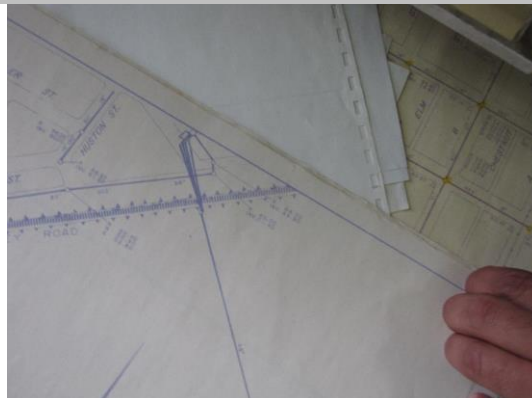
Photo 1 of 3 : UCIP\_FA\_2018\_52825\_69835.jpg

Comment Code						
Inspector Comment						
FS_ID:52825 DS_ID:19160 EP_NO: 2149 Repair Type: Non-Urgent Crossing Status: Indicator Found UCIP Comments: 03/14/2013 Depression observed on waterward toe filled with concrete rubble and riprap. Need to coordinate with City to determine records and extent of modifications if any. (DWR UCIP - O. Magana) FIELD_STRUCT_DESC: [17th & Howell Pump Station] 2 of 4: 10-inch steel drainage pipe, buried 15-feet below the crown. Runs parallel to other drainpipes, encased in concrete approximately 1-foot spacing. Pipe extends from storm water pump house to manhole (259 feet) north of landside (LS) toe. Flap gates and vent pipes at waterside (WS) toe. Discharges into concrete distribution box (3-foot by 4-foot). (three 30-inch and one 10-inch pipes and a 48-inch outfall pipe across the berm along the right bank of the Yuba River authorized under Permit No. 2149, 1956-City of Marysville). [Additional Reference(s): DWR Levee Logs, 1993 and 2005] FS Date: 3/14/2013

As-builts provided by Marysville Water Treatment.

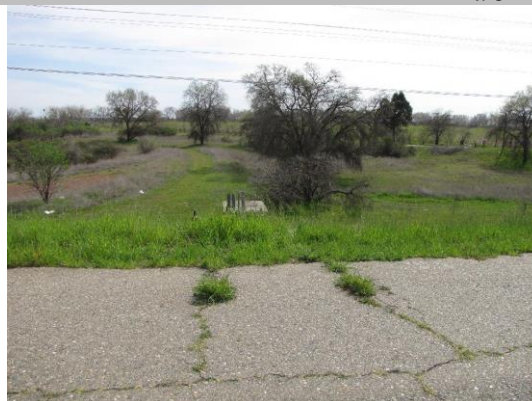
Photo 2 of 3 : UCIP\_FA\_2018\_52827\_69826.jpg

View of waterward side.

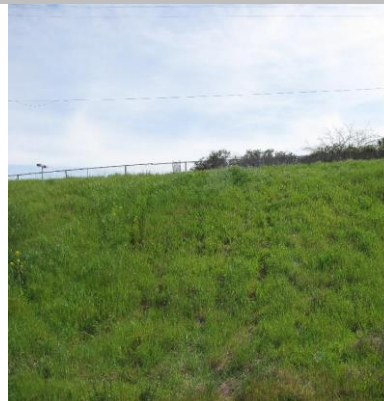
Photo 2 of 2 : UCIP\_FA\_2018\_52828\_25148.jpg

View of landward side.
